INTRODUCTION

The Port of Beirut explosions of 4th August 2020, situated within the boundaries of the Municipality of Beirut (MoB) and in close proximity to the neighbouring Municipality of Bourj Hammoud (MoBH), resulted in devastating loss of life, injury and the destruction of vast tracts of urban fabric within these municipalities and beyond.

One of the initiatives undertaken in response by the MoBH with the support of UN-Habitat was a rapid exterior visual survey at the building level, The survey covered all building types, to gain an understanding of the extent of damage and particularly structural impacts, immediately identifying buildings at risk of collapse and in need of evacuation whilst also providing evidence for formulating early recovery measures.¹

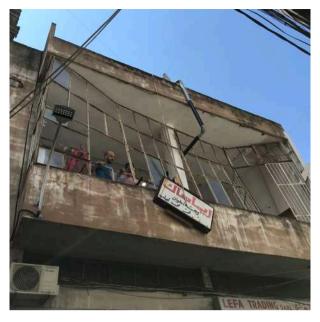
Unsafe / evacuate

Buildings that are structurally unsound and require evacuation.

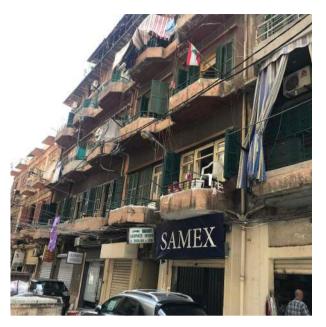
Safe / minor damage

Buildings that were subject to minor defects, such as broken glass.

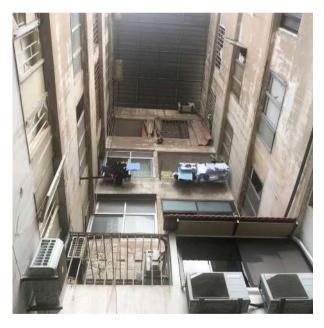
Restricted use

Buildings that incurred considerable damage in their architectural components (falling architectural elements that might affect public safety).

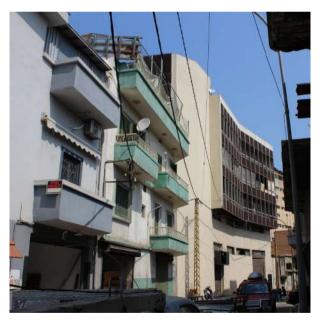
Not affected⁵

For buildings that were not affected at all.

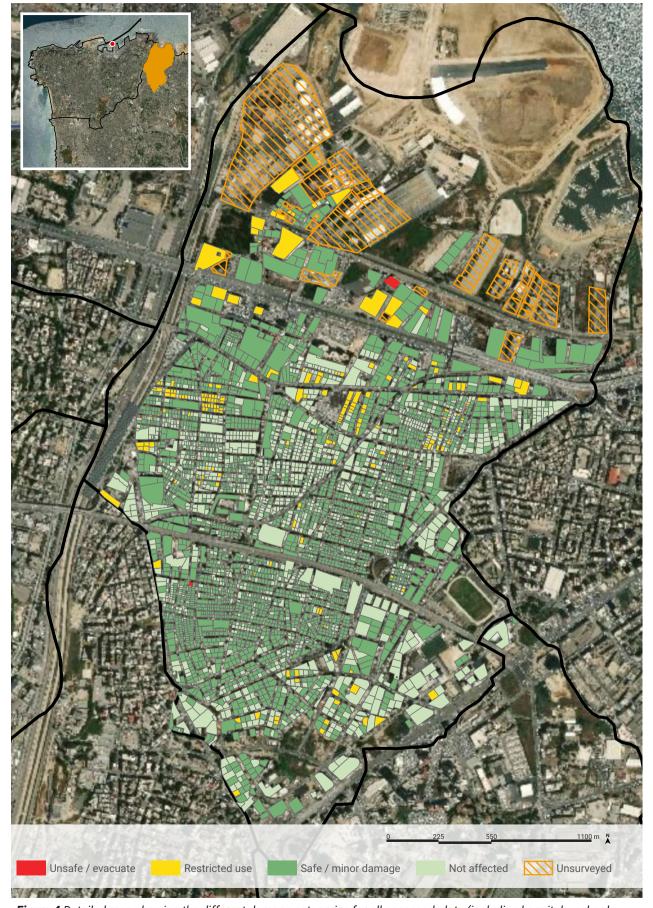
Figure 4 Detailed map showing the different damage categories for all assessed plots (including hospitals, schools and heritage buildings)

Building damage category	Assessment Count	Assessment %
Unsafe / evacuate	4	0.10
Restricted use	182	4.68
Safe / minor damage	1,957	50.27
Not affected	1,708	43.87
Unsurveyed	42	1.08
Total	3,893	100
