ENHANCING AND DEVELOPING SEISMIC RISK ASSESSMENT FOR TAUNGOO CITY OF MYANMAR

Taungoo City, Bago Region, Myanmar

Safer Coastal and Urban Communities through Inclusive Disaster Risk Reduction in Myanmar Project Funded by DIPECHO

December, 2015

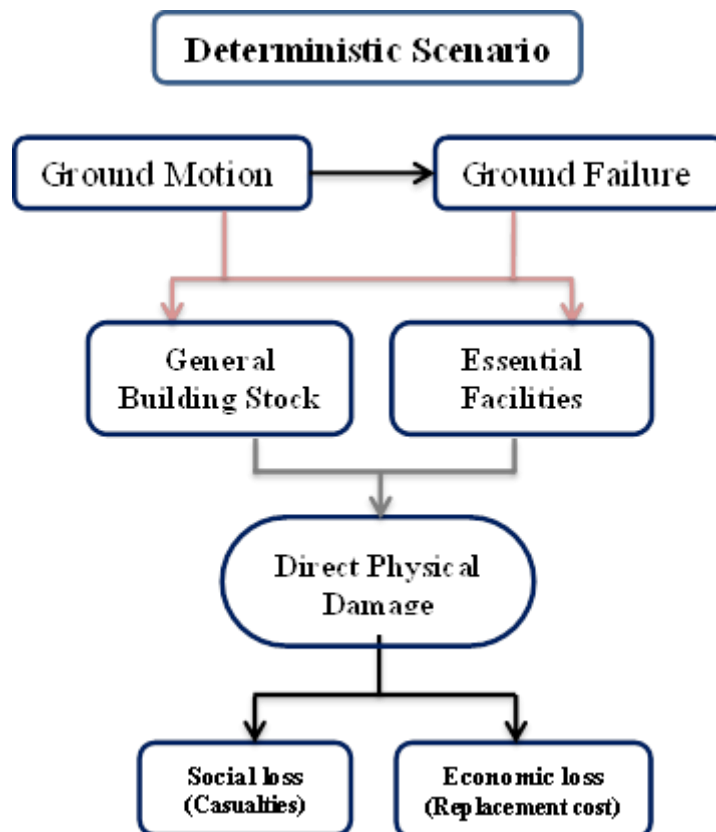
Figure (1) Flowchart of the Earthquake Loss Estimation Methodology adopted by HAZUS

HAZUS methodology for earthquake loss estimation model is used for risk assessment tool. The framework of the methodology includes Potential Earth Science Hazard (PESH), Direct Physical Damage, Induced Physical Damage, Direct Economic/Social Loss and Indirect Economic Loss. Inventory for general building stock and essential facilities are used as input data. Direct damage data of building and essential facilities, casualties, and economic losses are just developed as output result of HAZUS analysis because of limited resources. The earthquake loss estimation methodology can develop the preliminary estimation of damages to prepare before disaster situation and to plan and stimulate efforts how to reduce probable risk from earthquake. The flow chart of HAZUS methodology is shown in Fig (1).

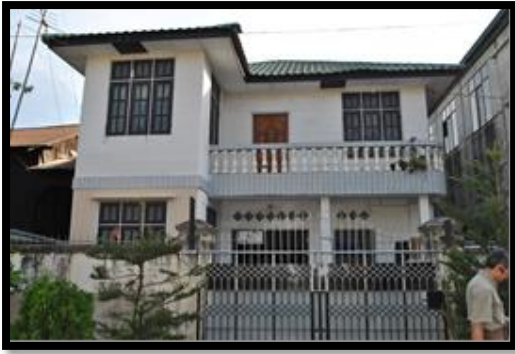
Reinforced Concrete Building (C3L)

Brick Nogging Building (RM1L)

Mixed- Use Building (MH)

Brick Masonry Building (URML)

Timber Building (W1L)

Figure (5) Different types of Structural Types in Taungoo City

Inventory data includes general building stock, essential facilities, and its related replacement cost. The former two inventory data deal with direct damage data whereas the latter is related to economic loss. Three groups of wards in Taungoo are classified depending on levels of economic condition; rich, medium, and poor, to take rapid visual screening survey. The main idea of dividing three groups is to get the different types of building and its use because of the interdependency between building type and income of the family. There are mainly five structure types which can be found in Taungoo. These are Timber, Brick Nogging, Reinforced Concrete, Brick Masonry, and Mixed-use. Timber building types are the most common type in Taungoo.

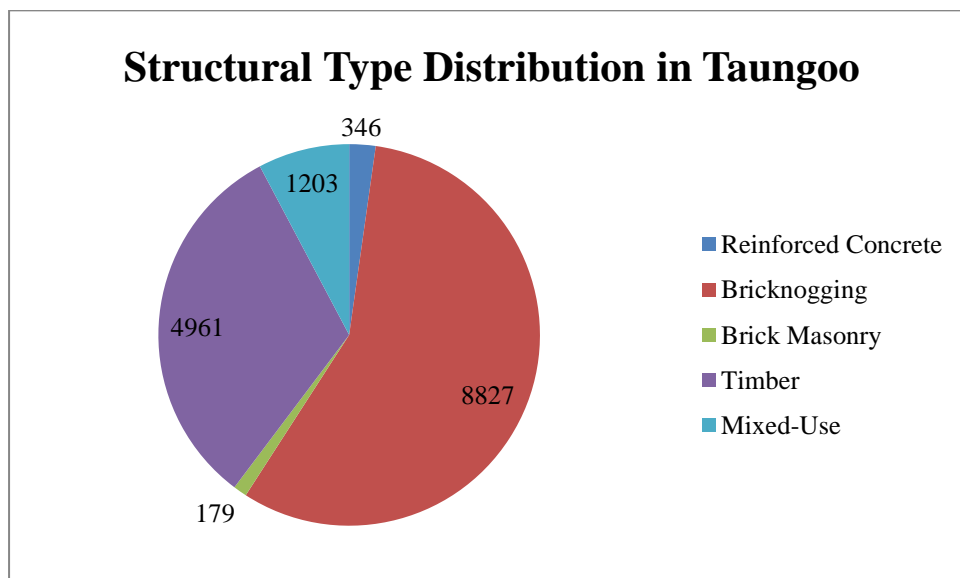
Figure (6) Structural Type Distribution in Taungoo City

The inventory information required for the analysis to evaluate the probability of damage to occupancy classes is the relationship between the specific occupancy class and the model building types. That occupancy mapping is created from the statistical distribution of on-street survey data. Table (1) shows definition of each structural type and table (2) and (3) show structural and occupancy types distribution of each ward in Taungoo.

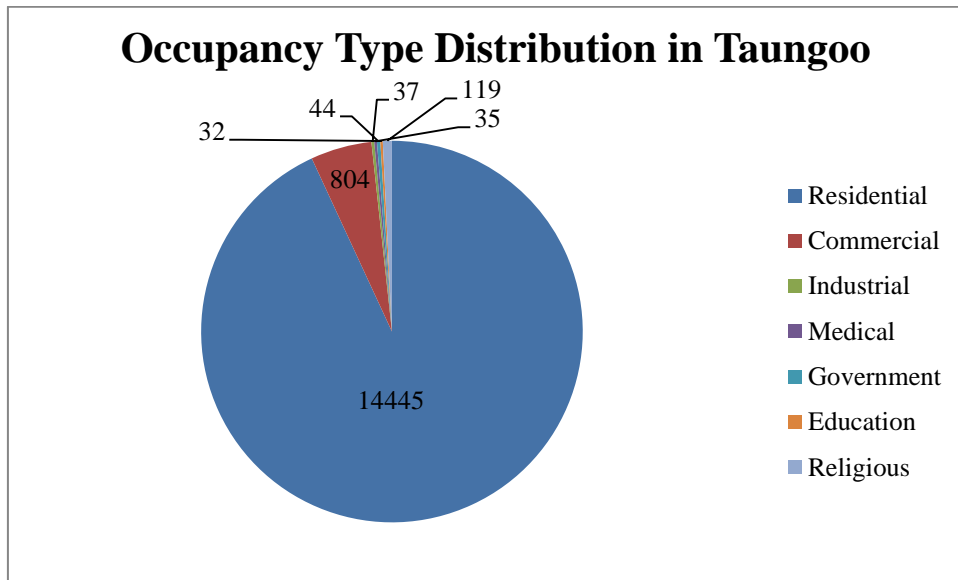
Figure (7) Occupancy Type Distribution in Taungoo City
