Bakalian Waste Storage Site Sampling Methodology and Analytical Report

Project Description

2. Methodology and Approach

3. Observations and Results

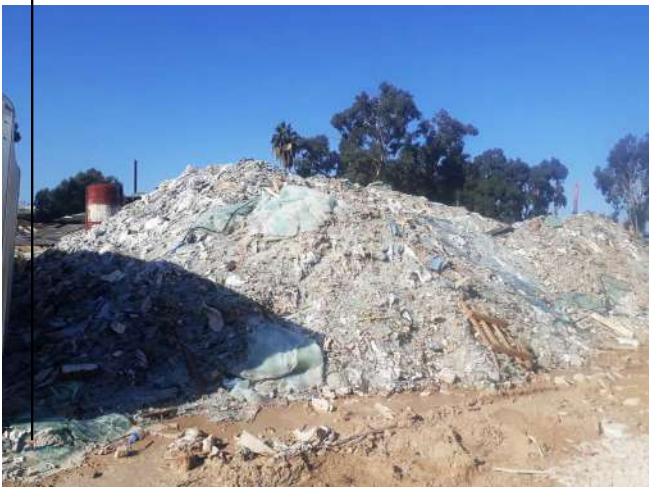
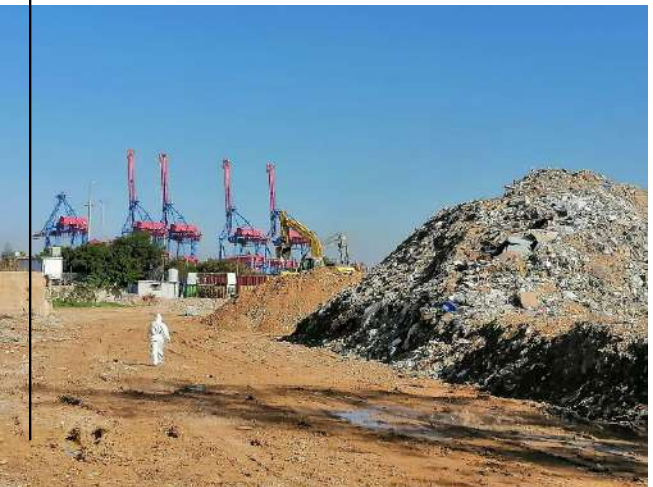
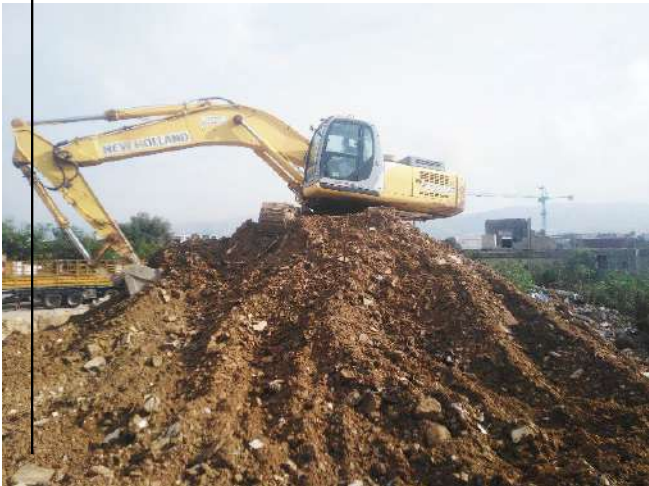
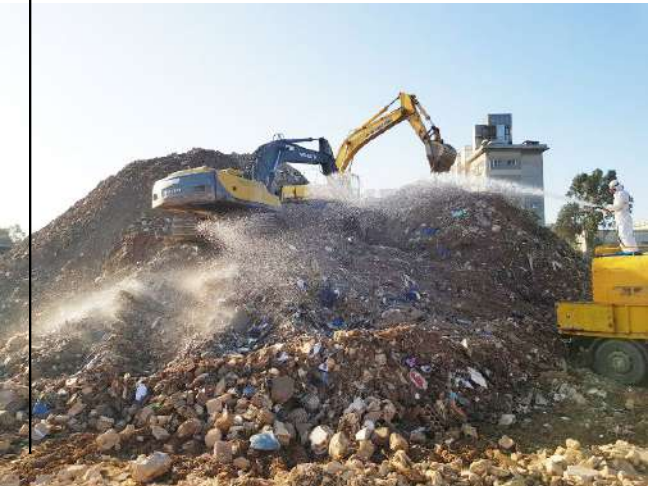
Figure 1. Four Stockpiles at the Bakalian Waste Storage Site / UN-Habitat © 2021

GLASS STOCKPILE

MIXED 1 STOCKPILE

RUBBLE STOCKPILE

MIXED 2 STOCKPILE

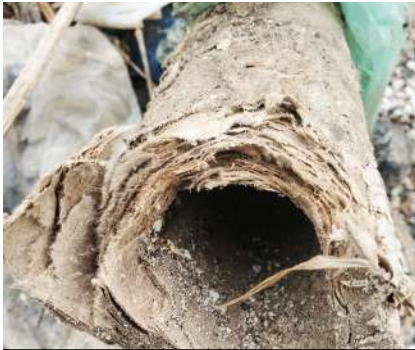
Presumed asbestos-containing paper mechanical insulation

ACM was identified through visual examinations conducted at various stages of site operations. When such materials were found, they were extracted and disposed of following proper procedures, which are outlined in IBI Group’s *Guidelines for Managing Asbestos at the Bakalian Disposal Site*. As explained in that document, disposable personal protective equipment such as coveralls must also be disposed of as asbestos-contaminated waste.

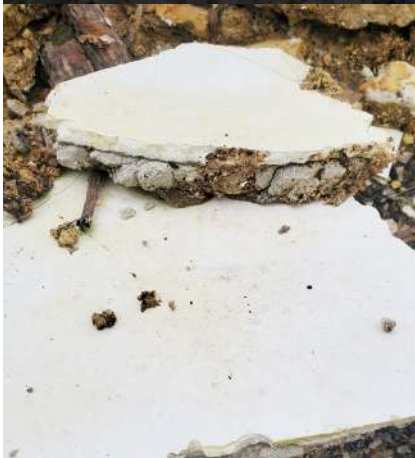
Presumed asbestos-containing plaster application

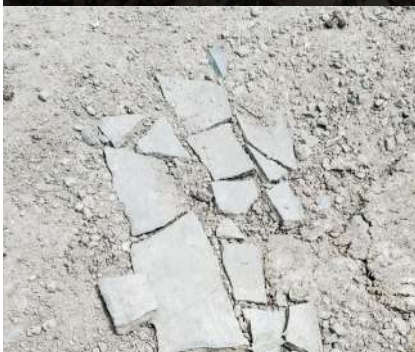
Presumed asbestos-containing cement products

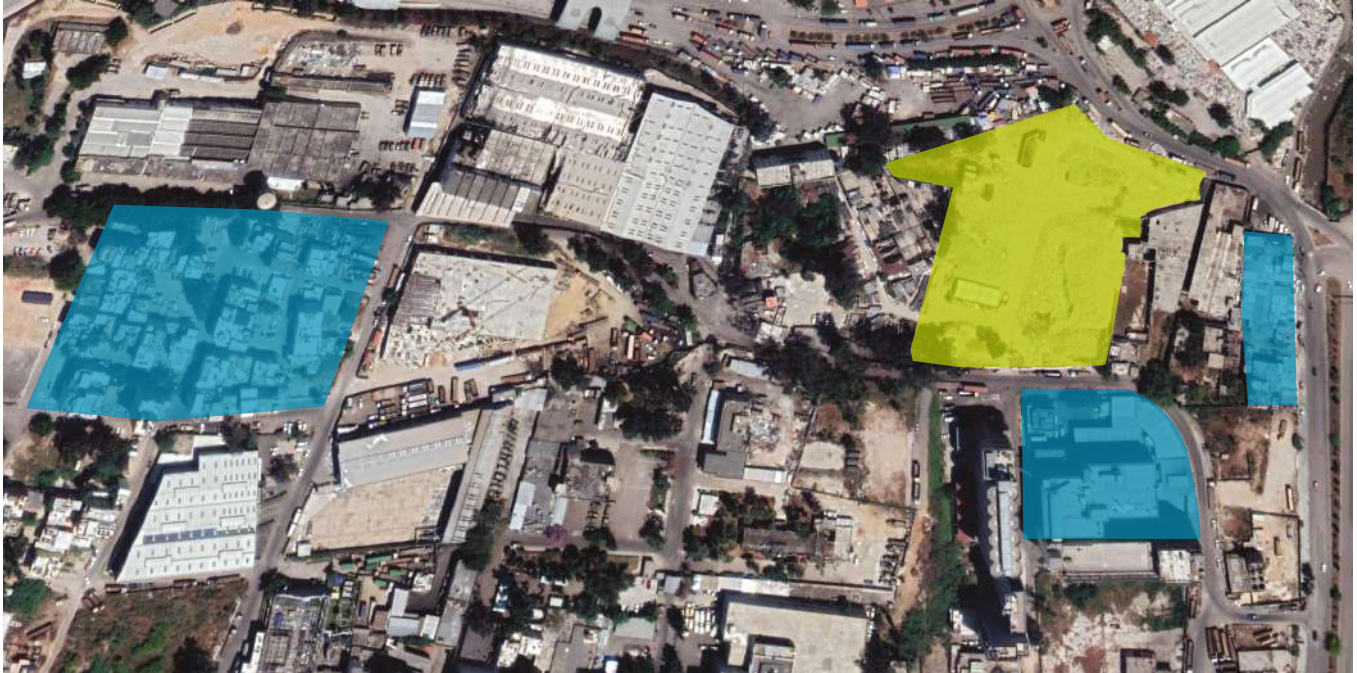
Figure 5. Areas for Air Sampling Outside of the Bakalian Waste Disposal Site
Original Image: Imagery © 2021 CNES / Airbus, Maxar Technologies, Map Data © 2021

1. The parameters for TCLP samples collected for analysis of lead content should be extended to include both organic and inorganic analytes to determine the presence of metals, pesticides, herbicides, semi-volatiles, and volatiles.
2. The air samples collected within the site were found to be clean. However, it is recommended that air samples be collected outside the boundary of the Bakalian waste disposal site to enable assessment of the air quality in an area beyond site operations. The location of this external collection point must be selected strategically to ensure it is representative of different functional spaces (e.g., residential, manufacturing, commercial). The figure below shows the areas that should be investigated (shaded in blue), as these areas represent different functional uses within the area surrounding the Bakalian waste disposal site.
